TEST REPORT

No.: IT14/1847-00

- 1.0. Equipment under test: Stainless steel closing system
- 1.1. Trade mark: MARTIN S.r.l.
- 1.2. Type: 70070
- 1.2.1. Version: --
- 1.3. Identification: C-14/0652 (1)
- 1.3.1. Part No. identification: --
- 1.4. Applicant's name and address: MARTIN S.r.l.
Via Cave, 1
IT – 25050 PROVAGLIO D'ISEO (BS)
- 1.5. Applicant represented during the test by the following person(s): --
- 1.6. Date of receipt of test objects: 25.11.2014
- 1.7. Remarks: --

A: EN 60529

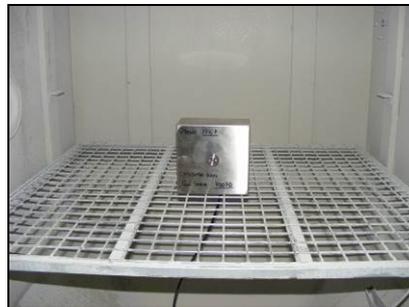
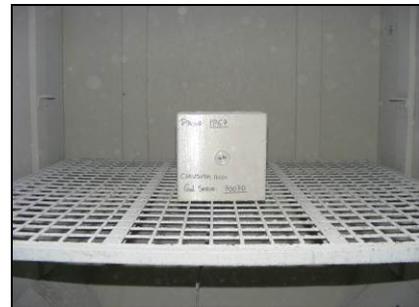
Photo test set-up:

The test sample, assembled on a metallic box by the applicant, was placed in the cubical dust test cabinet as agreed with the applicant and subjected to the following test conditions:

Test dust: Talcum
Test duration: 8h
Inside sample depression: 20 mbar
Extracted air volume: 0 m³
Dust suspension method: Continuous vertical direction flow (circulation pump)

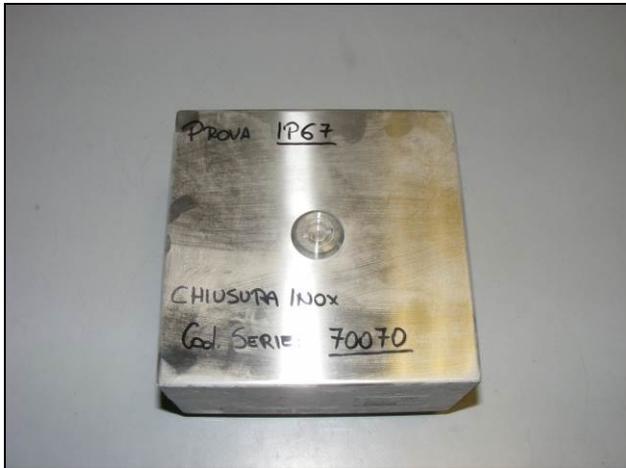
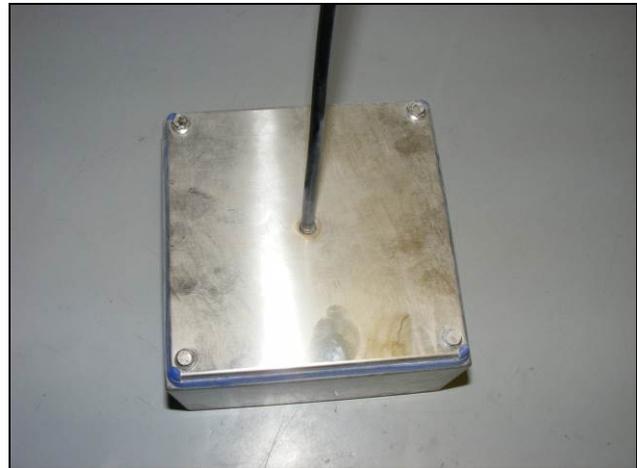
Photos of sample C-14/0652 (1) after the IP6X test

Used equipment: IP Dust Chamber ACS SD1000 F (ITST06028).
Performance criteria: No observable deposit of dust inside the sample at the end of the test.
Result: No visible dust penetration after the opening of the box. The sample was not opened immediately after the test.
Remarks: The internal check was carried out after the IPX7 test (see test protocol IT14/1847-00/02 and attached photos).
Classification: Passed Not passed n.a.
Date of test: 02.12.2014
Test location: FAKT S.r.l. – Rezzato (BS)
Operator: S. Tuana

(*) The internal check was carried out after the IPX7 test (see test protocol IT14/1847-00/02 and attached photos).

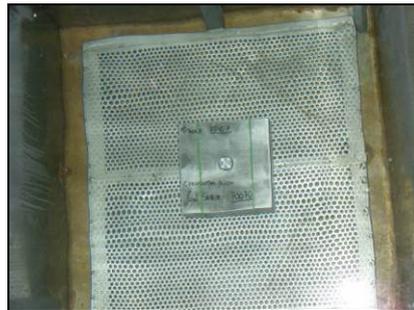
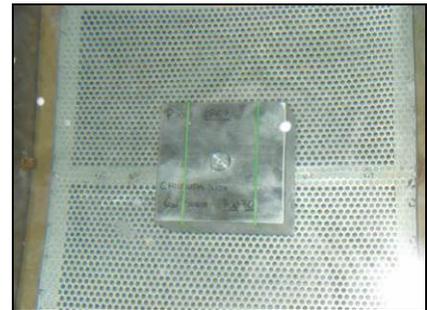
Photo test set-up:

The test sample was immersed in the test tank and subjected to the following test parameters:

Water-level on enclosure: 1 m

Test duration: 30 min

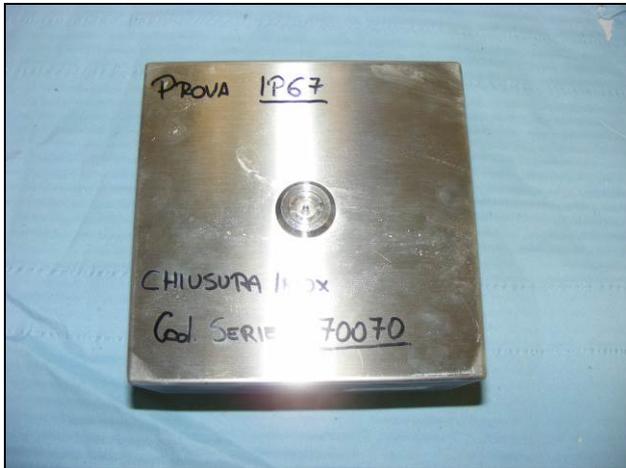
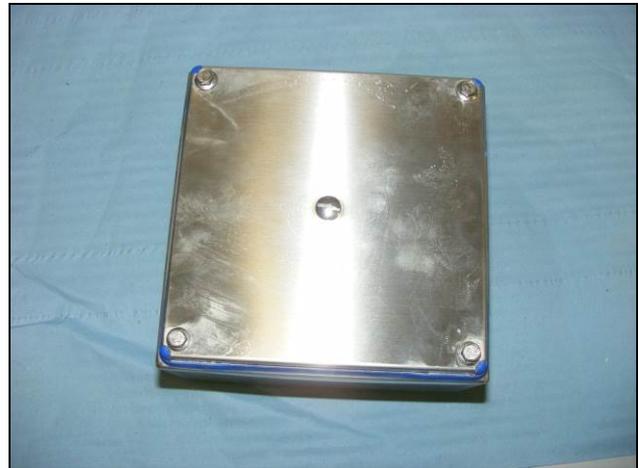
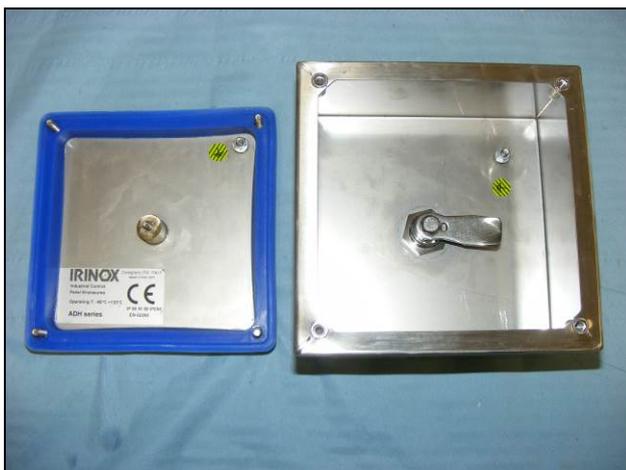
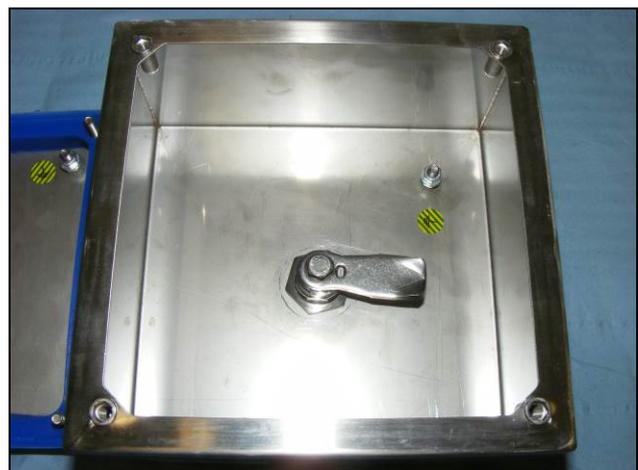
Photos of sample C-14/0652 (1) after the IPX7 test

Result: After the opening of the box, no visible presence of water.
No visible damage was detected after the test.
